Stibnite Gold Project EIS

Appendix E

Geologic Resources and Geotechnical Hazards

E-1: Geohazards Along the Proposed Burntlog Route

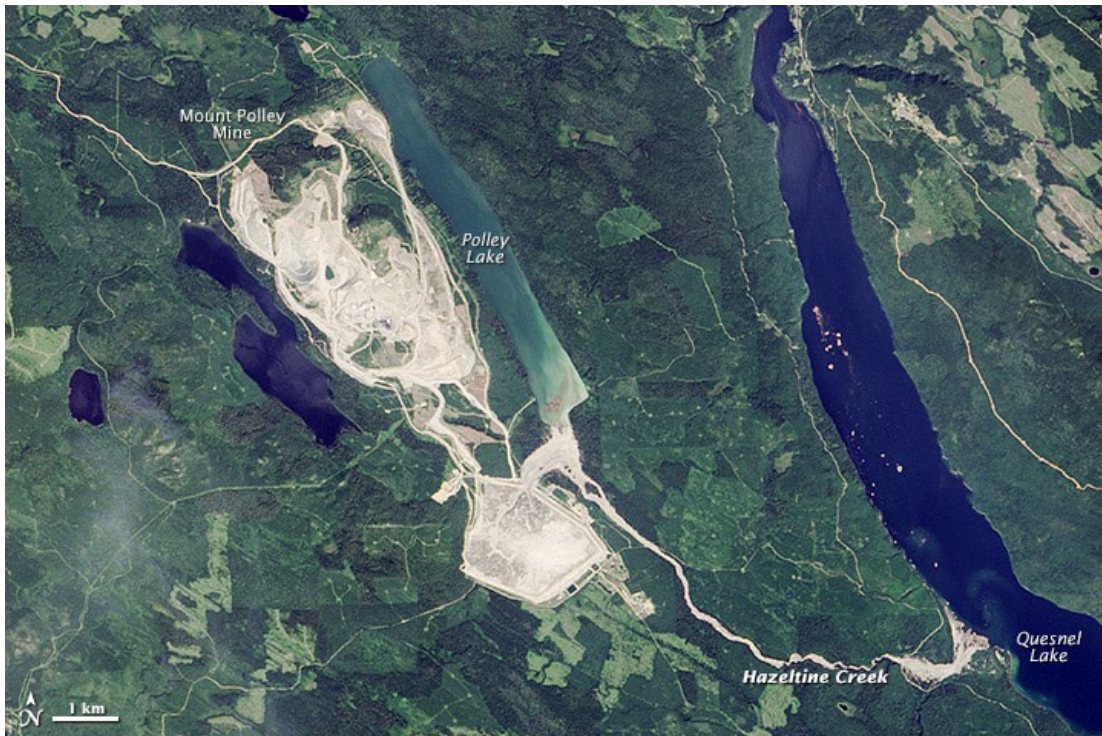
Figure 1 Mount Polley Before (July 24, 2014)

Mount Polley was a copper/gold open pit mine in British Columbia, Canada. On August 4, 2014, a breach occurred at the Perimeter Embankment of the Tailings Storage Facility (TSF). The breach occurred due to the failure of an underlying glacial lacustrine layer that was not appropriately characterized or accounted for in engineering design (Mining and Mineral Resources Division 2015). The TSF breach released an estimated 10.6 million cubic meters of supernatant fluid, 13.8 cubic meters of tailings slurry. This translates into approximately 17 million cubic meters of water, and 8 million cubic meters of solids (Resource Works 2019). This is the second largest mine waste spill on record (Bryne et al. 2018).

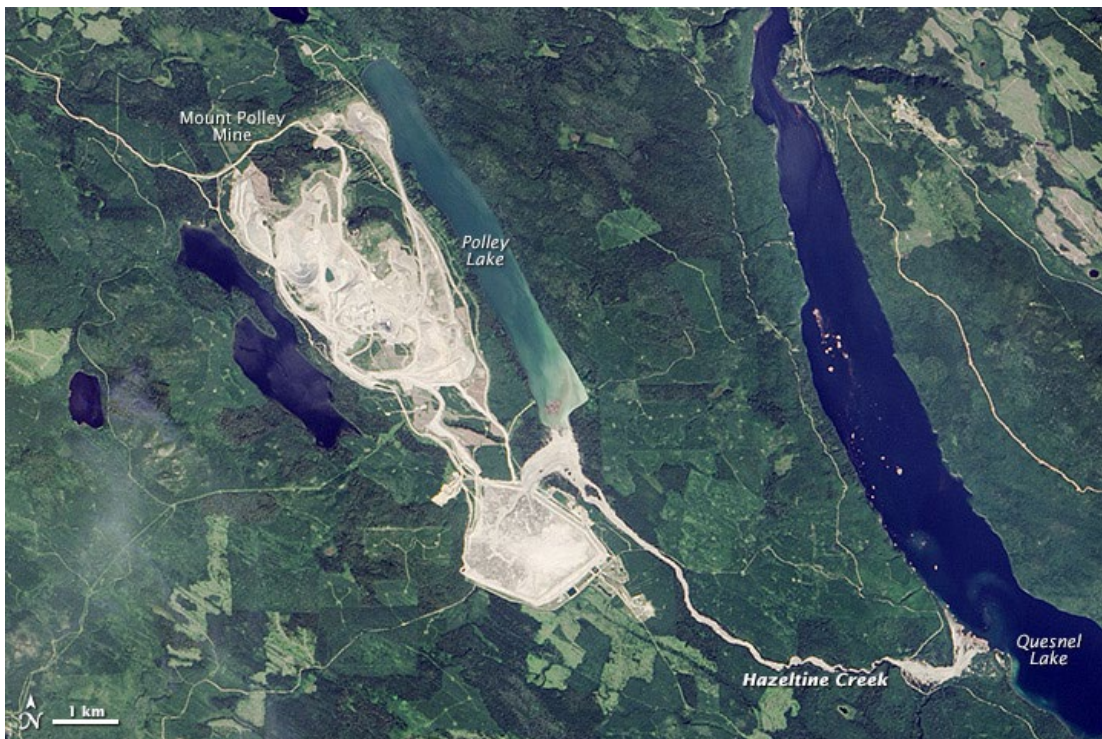
Figure 2 Mount Polley After (August 5, 2014)

This material flowed into the adjacent Polley Lake, and then down the 9-kilometer Hazeltine Creek channel to Quesnel Lake, causing 236 hectares (ha) of varying degrees of erosion and deposition in the creek valley, as well as deposition of tailings in Polley and Quesnel Lakes (Golder Associates Limited 2015). Only 20 percent of the materials in the tailings pond were released. There was no loss of human life.

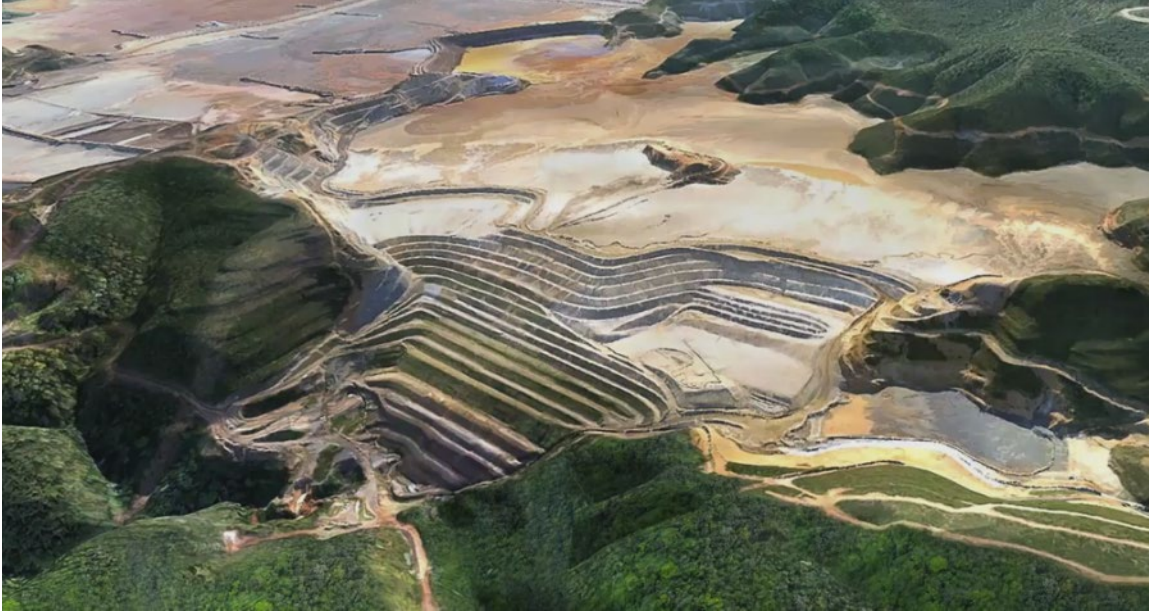
Figure 3 The Fundão Tailings Dam in 2015 before its Failure

On November 5, 2015, the Fundão Tailings Dam in Minas Gerais, Brazil collapsed. Its crest had reached 110 meters. The tailings were from the Germano iron ore mine.
